NATIONAL ADVISORY COMMITTEE FOR AERONAUTICS

TECHNICAL NOTE 2709

FATIGUE AND STATIC TESTS OF FLUSH-RIVETED JOINTS

By Darnley M. Howard and Frank C. Smith

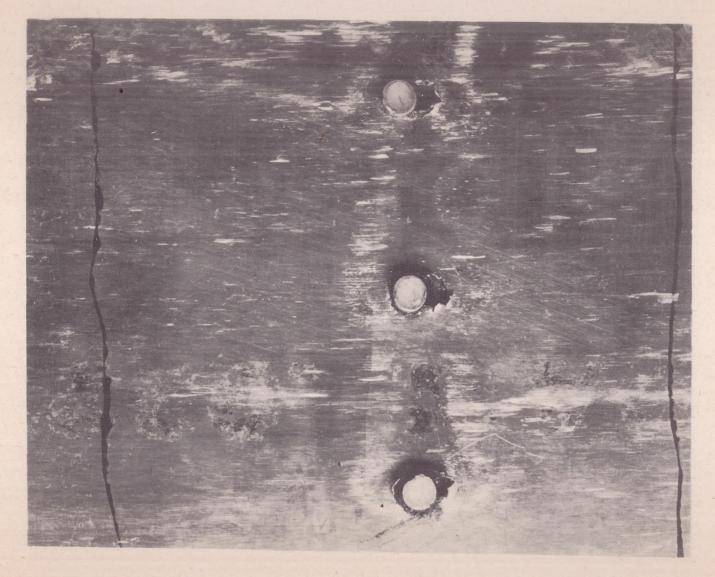
Elongation of the rivet holes and "cupping" of the rivet heads (fig. 6) occurred during failure of some of the dimpled joints. When this type of failure was obtained the number of cycles at failure was taken as the number at which the cut-off relay for stopping the machine was actuated. This relay functioned before the load could drop more than 7 percent. It was assumed that this tearing failure, once started, progressed rapidly and that consequently the load was fully maintained during the major portion of the test.

Figure 6.- Riveted joint that failed by rivet hole elongation.

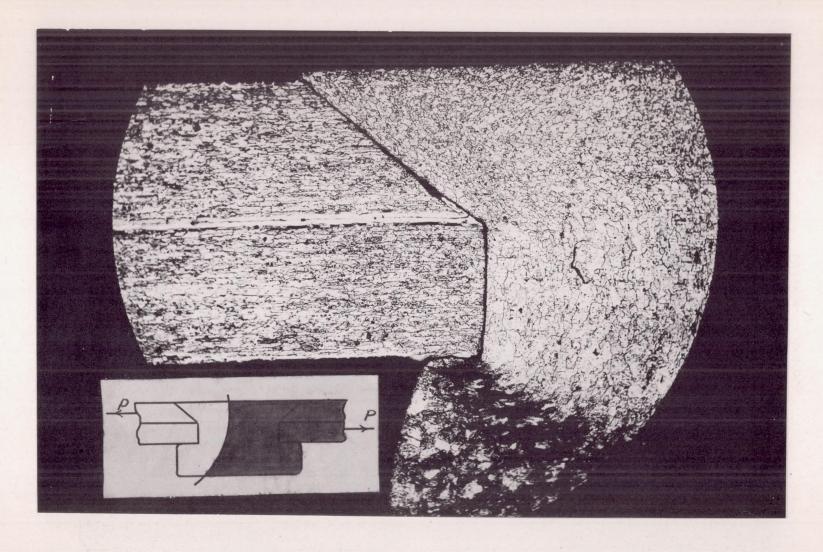
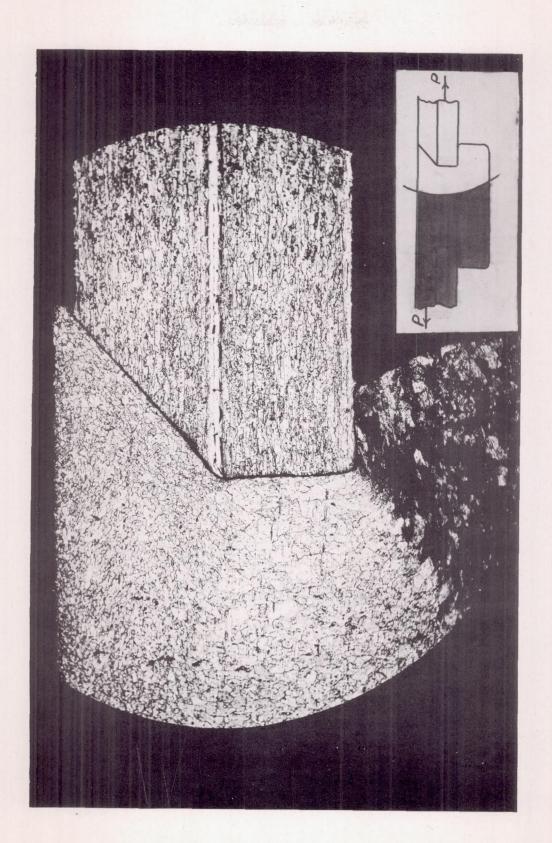
Figures 13(a) and 13(b) are photomicrographs of the left and right sides of a rivet in an 0.032-inch-thick alclad 24S-T3 aluminum-alloy lap joint with machine-countersunk holes. Photomicrographs of a similar joint after it had been subjected to 200 cycles of completely reversed load slightly above the 4-percent static-slip value are shown in figures 14(a) and 14(b). The fatigue loading caused gouging of the rivet, tipping of the rivet head, and deformation of the sharp edge of the upper plate.

Figure 13.- Rivet before test. Lap joint in alclad 24S-T3 with machine-countersunk holes.

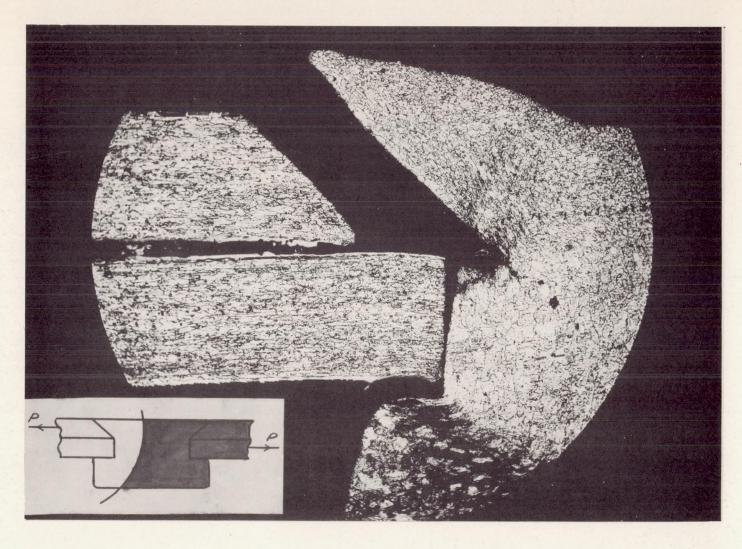
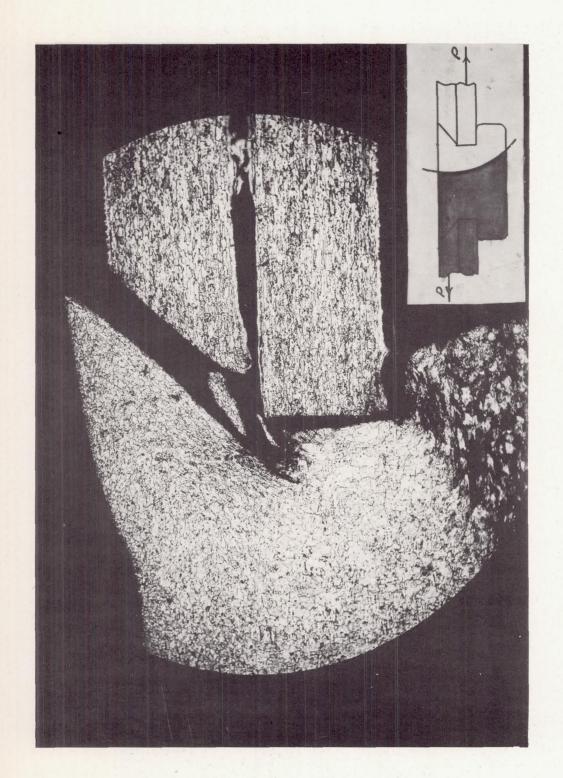
Figure 14.- Rivet after test. Lap joint in alclad 24S-T3 with machine-countersunk holes.

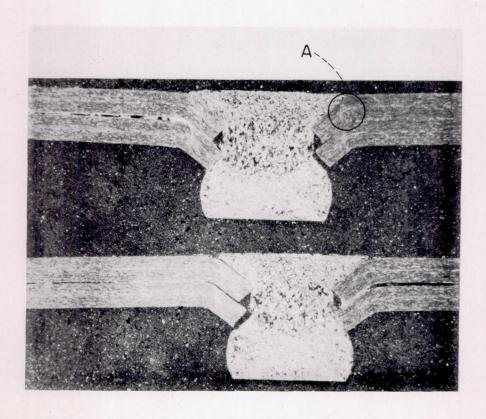
Figure 15 is a photomicrograph of typical 75S-T6 aluminum-alloy dimpled joints after fatigue failure. The deformation of the sheets and rivets due to cold-working during fabrication is clearly shown. It is interesting to note that the rivets do not appear to fill the holes

Figure 15.- Section of dimpled joints in 0.032-inch 75S-T6 aluminum-alloy sheet after fatigue failure. Cracks shown at A. X8.

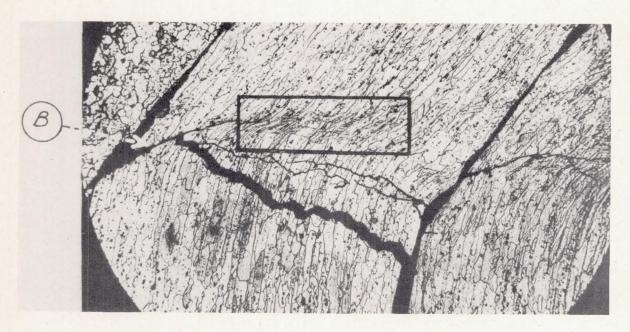
completely in these joints. The damaged area at A (fig. 15) is shown much enlarged in figure 16. The crack began apparently at the point of highest cold-work B (fig. 16) and initially propagated in the direction of the slip lines. A secondary crack on the convex side of the sheet may have affected the direction of propagation as the failure progressed. A similar crack in another joint is shown in figure 17.

Figure 16.- Cracks at A in figure 15. Crack started at B, began to move through heavily cold-worked area (rectangular box), and changed direction probably because of higher stressing along line of eventual failure. X100.

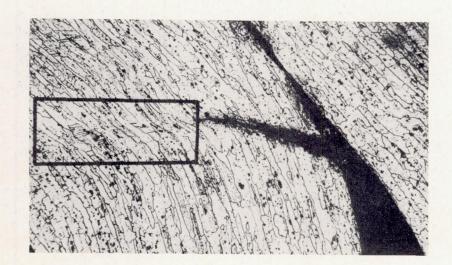
Figure 17.- Secondary crack on convex side of dimple in 75S-T6 alloy. Crack propagation through area of heavily cold-worked material (rectangular box). X100.
